# STABILIZATION OF A ROCKY CLIFF BY A GEOSYNTHETIC REINFORCED EARTHFILL

ABSTRACT: The paper deals about criterions and methodology used to design the reinforcement of a rocky cliff by an earthfill reinforced with geosynthetics. The earth structure has been built along the left side of Cornappo creek (Nimis - Ud), near a bridge called "ponte degli Angeli", in Torlano village. The unstable cliff has a length of about 70 m and an height of 12 m - 13 m and induces critical safety conditions in a group of buildings locate just at the slope top. Conglomerates and puddingstones weakly cemented by carbonates that are easily dissolved by rill and underground water, by the seepage along the rock fractures and river floods form the rock mass. All these elements caused the cliff backward and the formation of rock cavities, 2 m - 3 m deep, with a 10 m thick rock layer above their roof. The aim of design was to stop instability phenomena development by realisation of an earthfill, characterised by a low environmental impact, to support the rock mass and to protect it from rill and underground water.

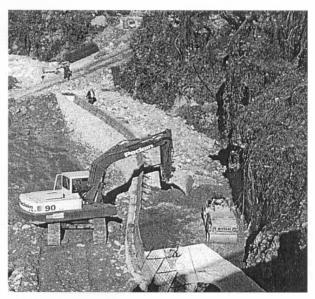
Figure 7. Construction of first layers of reinforced earthfill. In fore-ground the reinforcing metal braces.

Then, 11 polyester geosynthetic nets, with a length of 5.0m and with a ultimate tensile strength of  $T_{ult}=100kN/m$  for the first five sheets and a  $T_{ult}=40kN/m$  for the others, were used to reinforce the bottom part of the earthfill, extending to a height of 6.60m. Each sheet, located on the vertical plane at intervals of 0.6m, was connected to an external retaining structure made with steel net sheets, shaped at an angle of  $70^{\circ}$  relative to the horizontal plane and reinforced with metal braces (Fig. 7).
